GASIL

General Aviation Safety Information Leaflet

Issue no. 5 of 2012

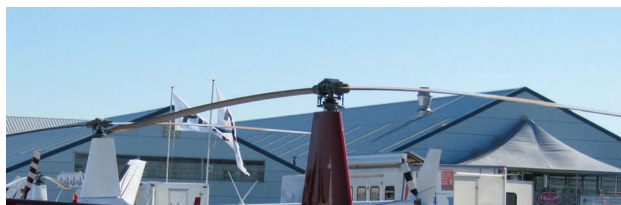
A recent incident report concerned a Robinson R44. During routine maintenance, a rod in the main rotor pitch link was found to be bent. The report suggests a possible cause may have been that the blades had been allowed to flap excessively while the aircraft was parked outside.

High and gusty surface winds are experienced relatively frequently in this country, often stronger than forecast.

Most commercial operators tie their rotor blades down as a matter of routine when their aircraft are left outside, as recommended in Flight Manuals. Perhaps all owners and pilots should consider doing the same?

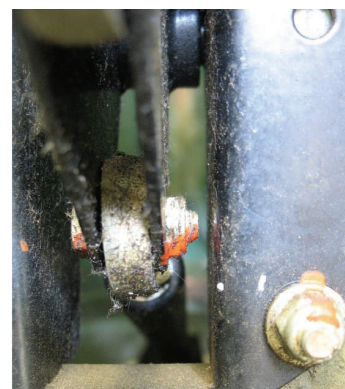
The elevator had become disconnected from the control linkage, and the investigation concluded that the bolt holding the linkage together inside the tailplane had fallen out as a result of being too short for the locknut which was fitted to it. The connection is invisible to normal daily inspections, and is apparently in an awkward position.

The investigation concluded that the bolt used for the connection was of a size approved by the manufacturer, but that the locknut fitted was probably incorrect. Instead of the flat locknut specified, a normal raised locknut had apparently been fitted, which did not grip on the threads and which could therefore fall off.

Although damage seems to have been evident to the remainder of the linkage, the bolt had apparently held for some time, before choosing the particular take-off to fall out completely. A pilot confronted with such a problem would have very little time available to close the throttle before the aircraft reached a point where serious injury was likely.

It is essential that the correct bolt (material specification, diameter and length) and the correct nut (material, diameter and depth) are used to ensure that the installation is maintained as designed. A general guide is that at least two threads would normally be visible following installation of the correct nut onto the correct bolt. This is particularly critical in installations where the connection cannot be inspected for security during routine pre-flight or pilot centred inspections. It should also be remembered that such connections require independent or duplicate inspections to be carried out.

Following the BFU's safety recommendation, it seems Mandatory Service Bulletins for HK36 and DA20 have been issued by the manufacturer.
