Australian Government
Australian Transport Safety Bureau

Engine failure and collision with terrain involving Robinson R44, VH-KJJ

154 km south-west of Timber Creek, Northern Territory | 14 June 2015

ATSB Transport Safety Report
Aviation Occurrence Investigation
AO-2015-062
Final – 17 November 2016

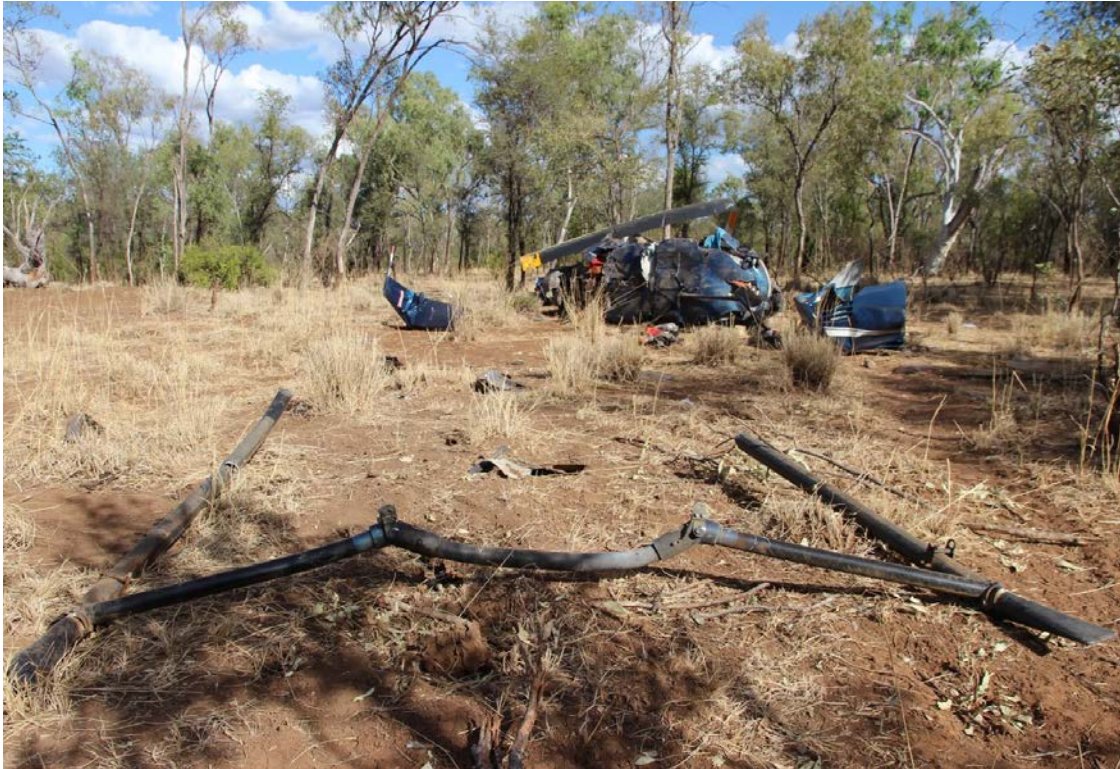
Figure 2: Accident site showing the surrounding terrain and wreckage distribution (looking south-east)

Damage to the engine, airframe and skids indicated that the helicopter impacted the ground in an upright, relatively flat attitude, with some forward movement and a high rate of descent.

Calculations based on impact damage to trees located along the flight path indicated a final descent angle of about 40°.

The main rotor blades sustained penetrating damage to the blade skins, with little evidence of impact damage to their leading edges. Upward bending of the main rotor blades was also evident.

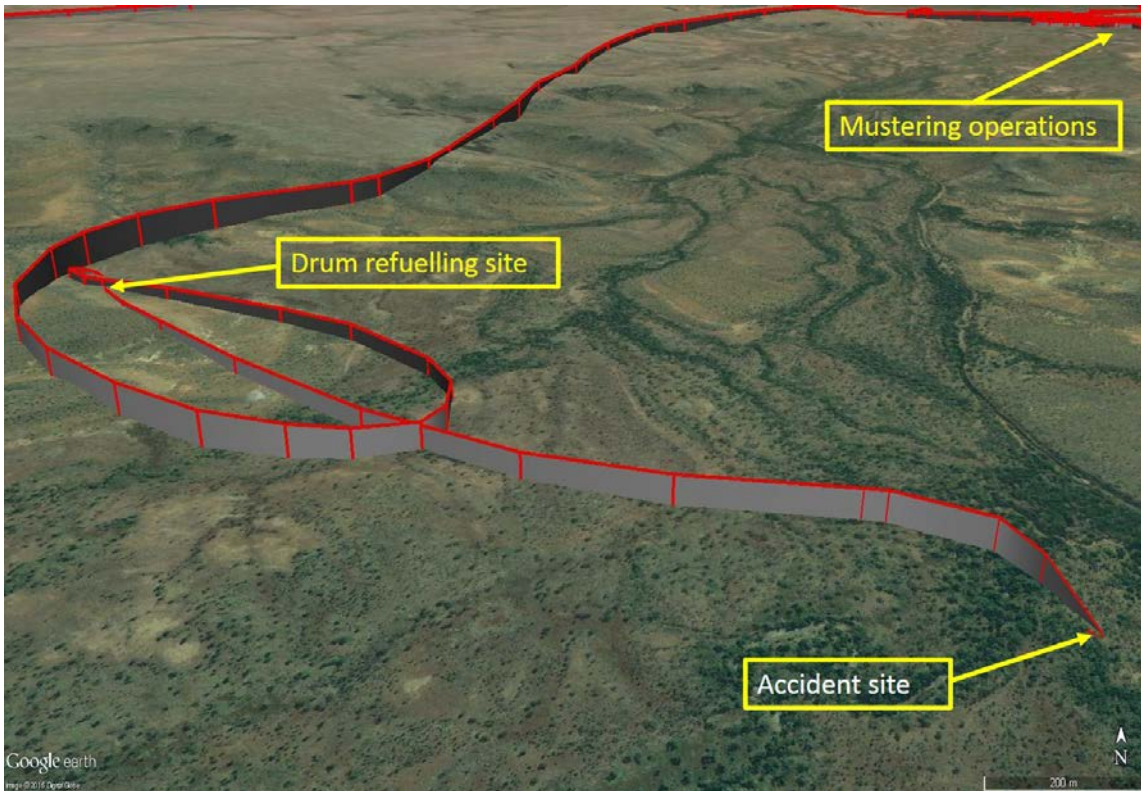
Figure 3: KJJ's recorded GPS flight path, showing the helicopter's track from the drum refuelling site to the accident site

The helicopter's GPS was recovered for further technical examination and download at the ATSB's technical facilities in Canberra, Australian Capital Territory. The downloaded data provided information about the operation of the helicopter on the morning of the accident including the final flight path (Figure 3).

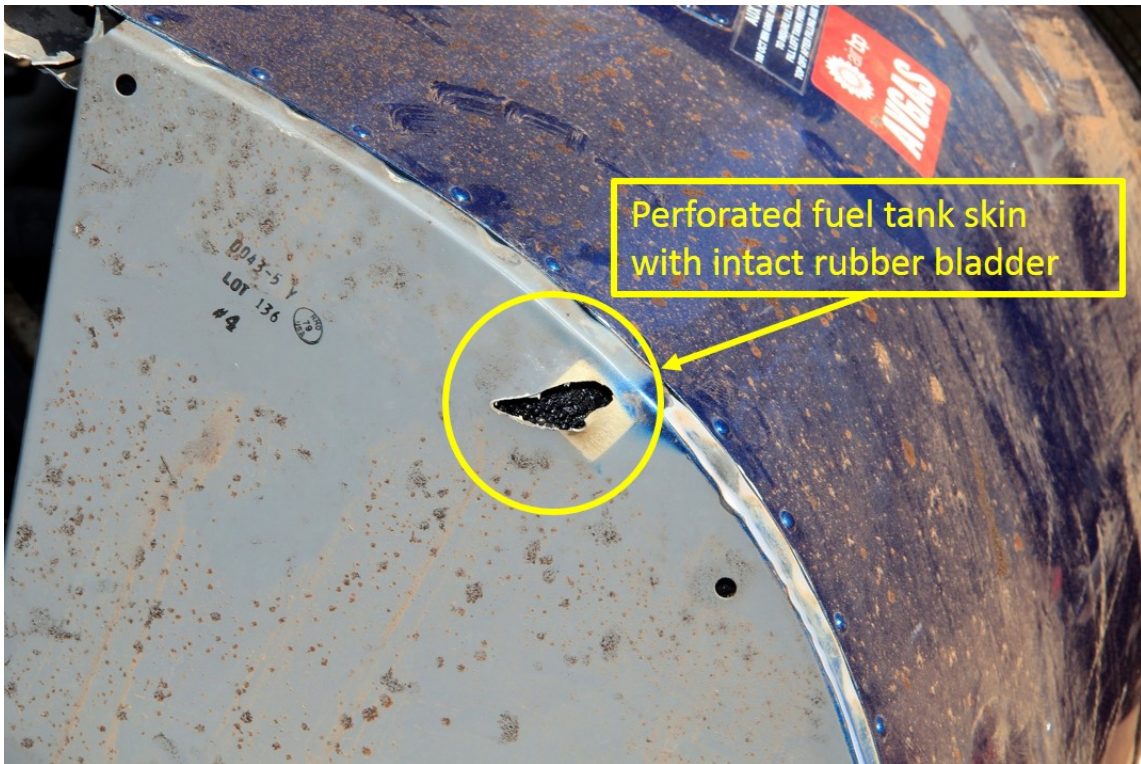
Figure 4: Perforated auxiliary fuel tank outer aluminium skin. Note the intact rubber bladder tank (circled in yellow)

The R44 has two interconnected fuel tanks. The main fuel tank holds 112 L total useable fuel and the auxiliary fuel tank 64 L useable fuel. Both fuel tanks were fitted with fuel tank bladders, which remained intact despite the outer aluminium skin being perforated during the accident sequence (auxiliary tank shown at Figure 4). Both fuel tanks were almost full, consistent with the recent drum refuelling.

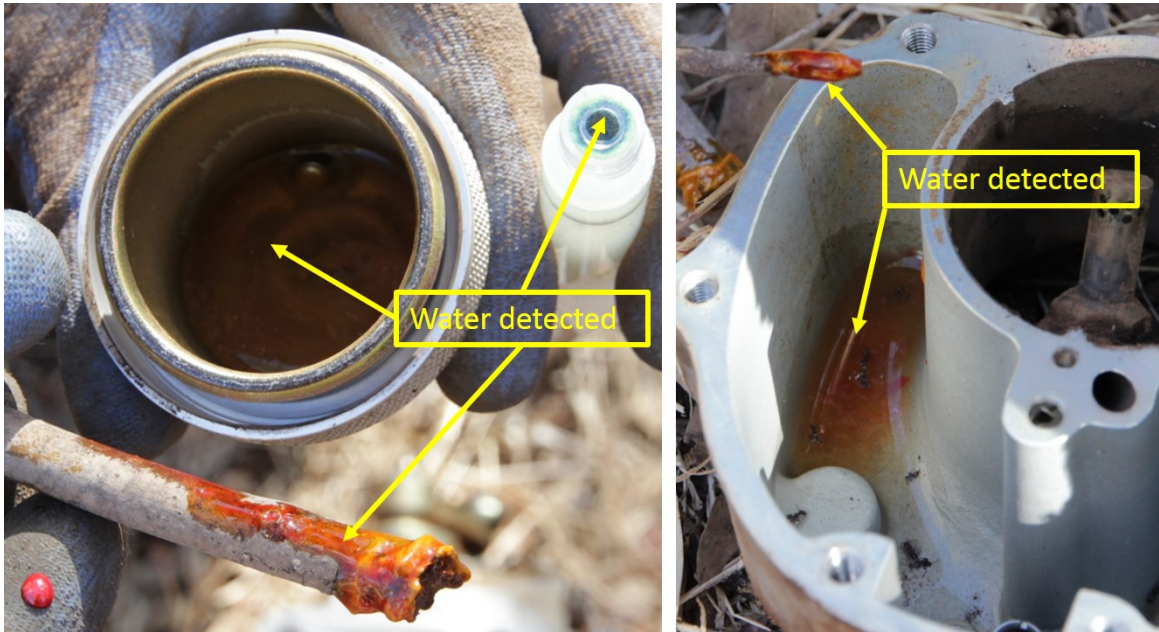
Figure 5: Gascolator (left) and carburettor (right) showing fuel contamination as indicated by the change in colour of the water detecting paste to red

On-site samples from the helicopter's gascolator (fuel strainer), carburettor and fuel tanks identified the presence of water and particulates (Figure 5 and Figure 6). Approximately 800 mL of water was drained from the auxiliary fuel tank and water was also siphoned from the main tank. Residual water remained in the tanks and could not be drained due to the crush damage to the fuselage. A fuel tank dip test with water detecting paste confirmed that a depth of about 3.5 cm of water remained in the lower areas of each tank.

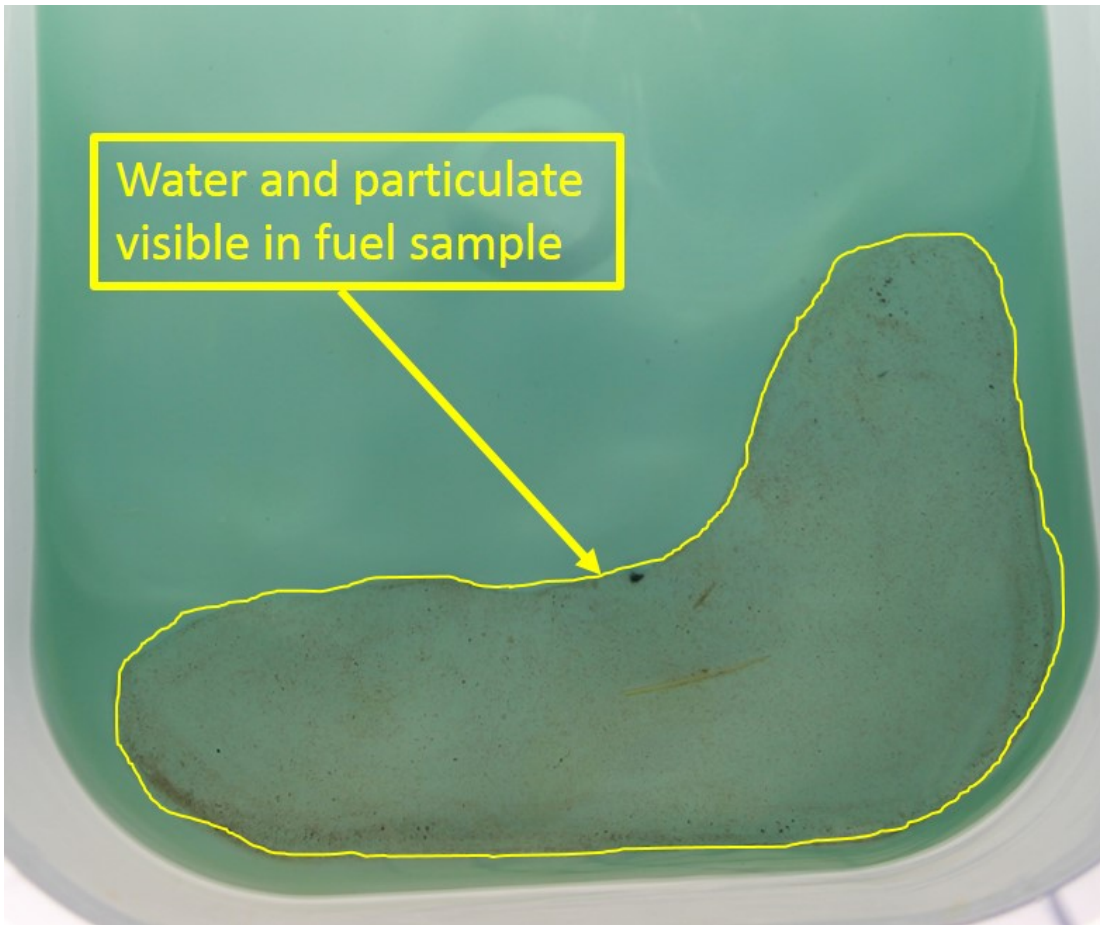
Figure 6: Water and particulate matter identified in a fuel sample obtained from KJJ's fuel tanks

Fuel samples that were able to be recovered from the helicopter's fuel tanks were heavily contaminated with water and rust-like particles (Figure 6). This contamination was similar to that identified in the fuel sample taken from the older, rusted fuel drum that was first used by the pilot during the drum refuelling.

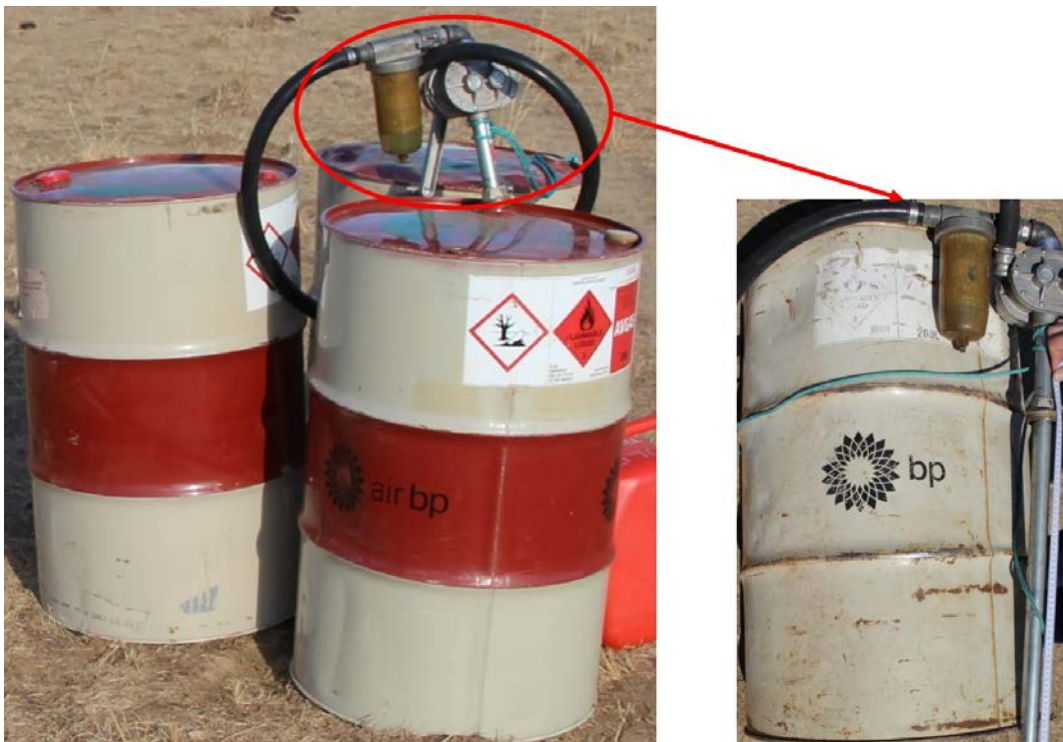
Figure 7: Drum fuel supply with a close-up (right) of the older, rusty and dented Avgas fuel drum. The left picture shows the drum fuel hand pump positioned in the newer of the two open drums

The three 200 L drums of Avgas that were relocated from the station's aircraft hangar were found upright in an open paddock close to the mustering operations (Figure 7). The two open drums and their contents were examined by the ATSB to eliminate them as potential sources of fuel contamination. The drum fuel hand pump was found positioned in the newer of the two open drums.

The older, rusty and dented drum contained a mixture of about 6 L total of fuel, rust and water. The inside lining of that drum was heavily rusted and was considered not suitable for aviation use.

It was probable that most of the contamination was introduced into KJJ's fuel system while refuelling from the older, rusted and damaged drum. This was consistent with the negligible amounts of water, rust or particulates identified in the operator's other fuel supplies. The water and rust particulates in the old, rusted and dented drum may have resulted from its storage unused for a period in a hot and humid environment.

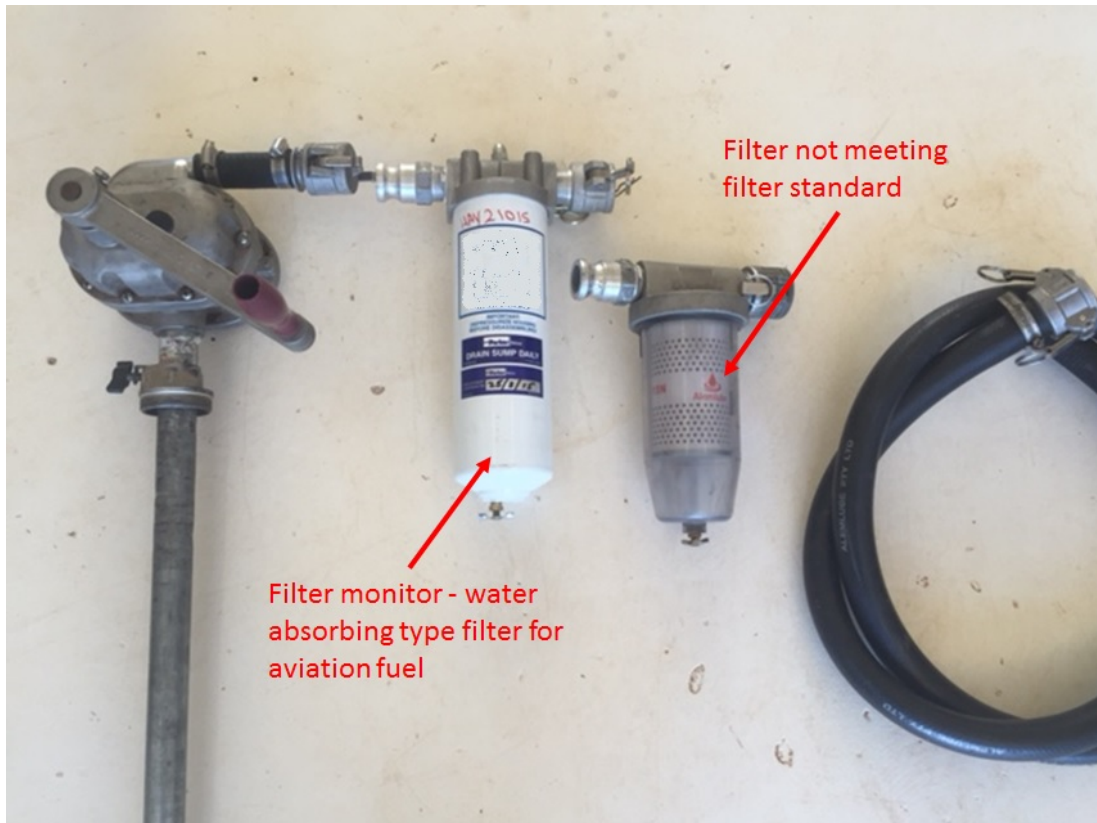
Figure 9: Examples of two types of filters used during drum refuelling. Note the off-white filter monitor (at left) meets the industry standard

A filter monitor-type filter is also shown in Figure 9. This filter has a much higher capability to remove particulates than the particulate filter shown. It can also absorb any water present in aviation fuels, except that it is not recommended for use with fuel containing anti-icing additives. As water and/or particulates are absorbed within the filter, differential pressure increases and reduces the flow. The reduction in the flow depends on the level of contamination in the fuel.

The results of the operator's test would suggest that it would be appropriate for individual operators to assess the suitability and practicality of the available filter monitors to their operations.

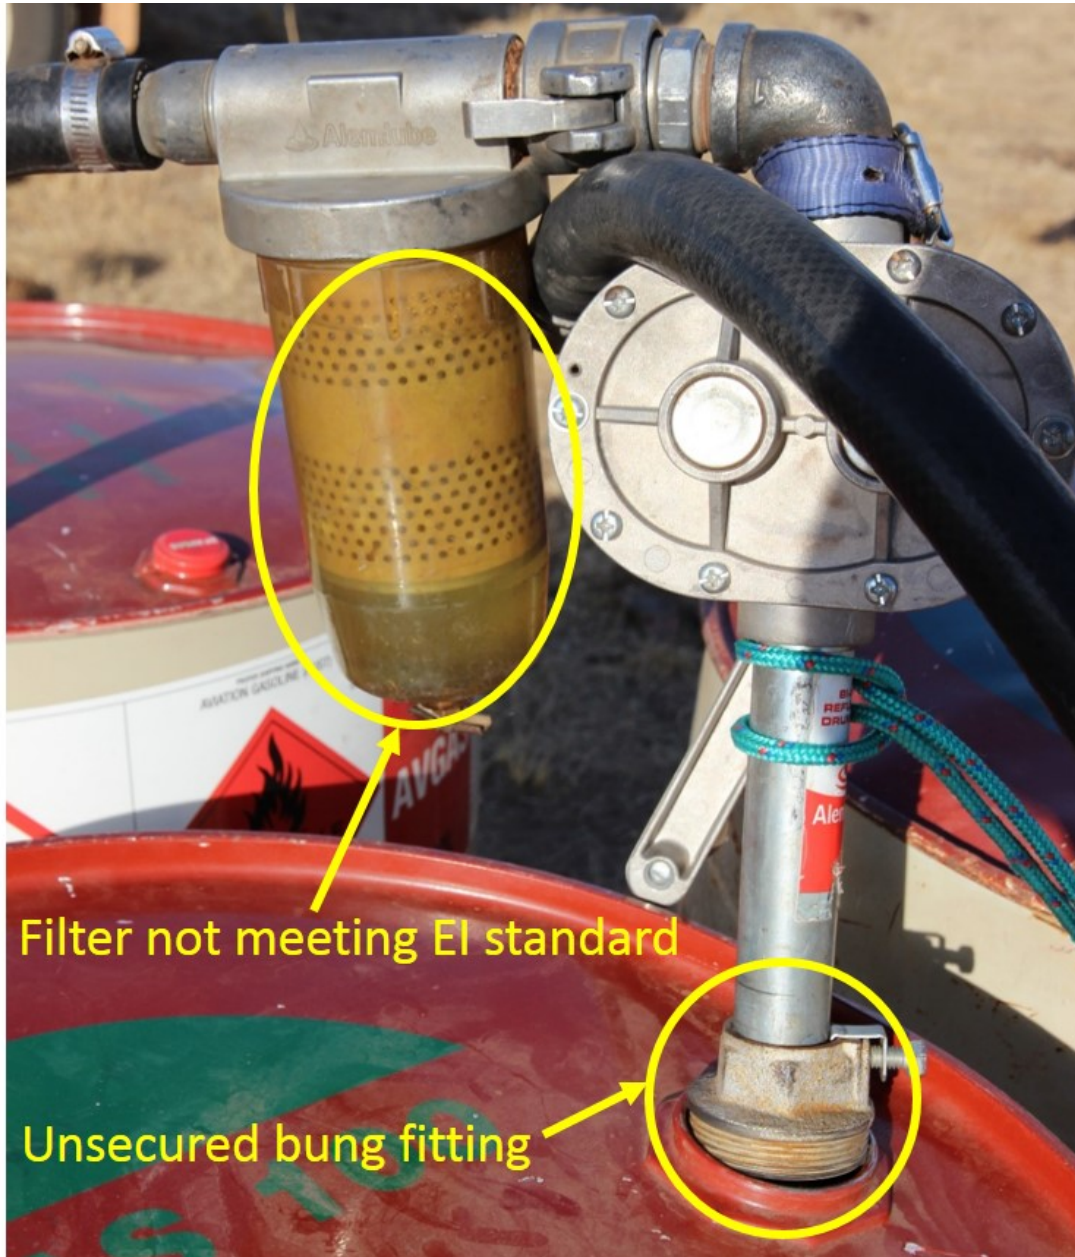
Figure 10: Drum refueling equipment used to refuel KJJ, showing the unsecured bung fitting

⁴ During refuelling, the practice of keeping the fuel drum tilted so that the large bungle is on the high side ensures the hand pump inlet pick-up is away from potential contamination on the low side of the drum.

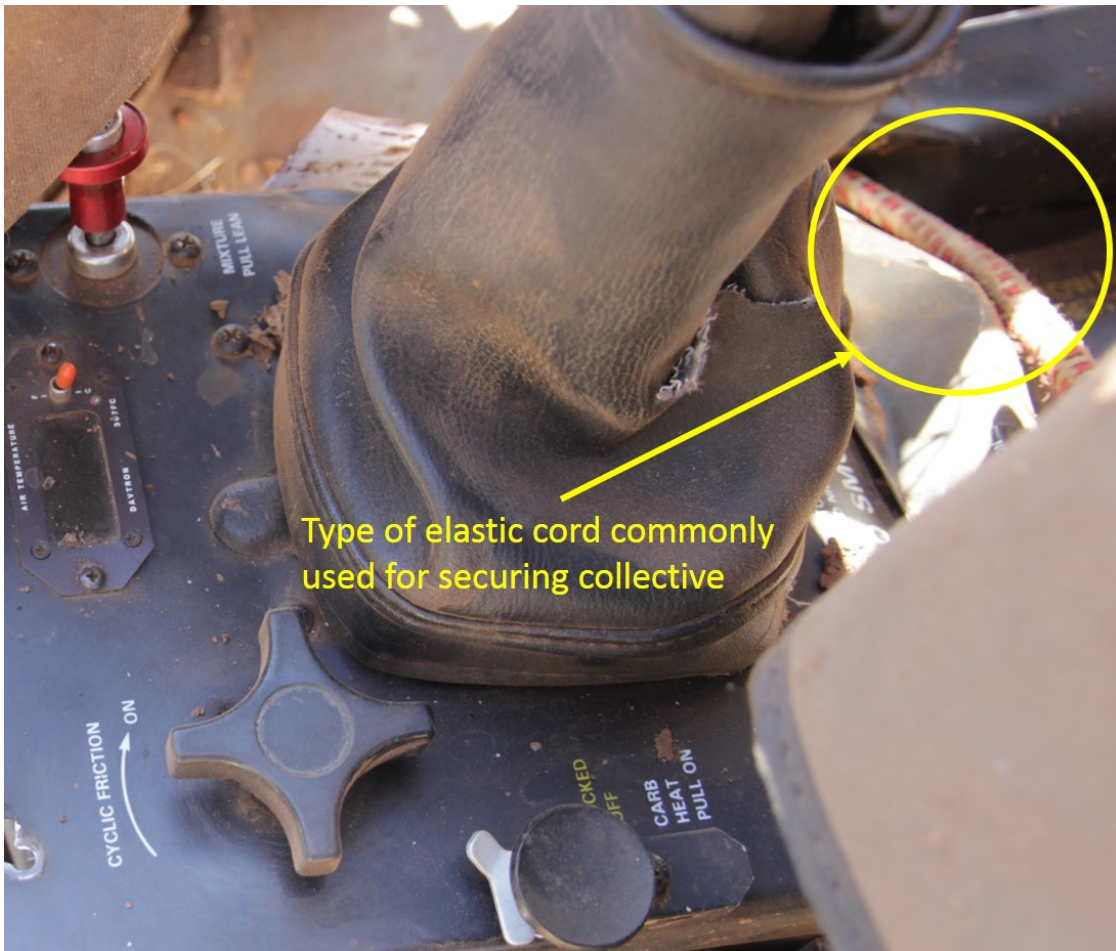
Figure 11: Elastic strap found positioned near the collective (such as reported used by some pilots to secure the collective lever)

To prevent inadvertent upward movement of the collective lever, it was reported by a number of helicopter pilots that an elastic strap was commonly positioned over the lever. There was evidence that the pilot of KJJ may have used this technique while not at the controls of the helicopter during ground operations (Figure 11). However, no approval for this method of securing the flight controls was found in the helicopter's maintenance documentation. In any case, the POH stipulated that pilots must not leave flight controls unattended while the helicopter is operating. Civil Aviation Regulation 138 *Pilot to comply with requirements etc of aircraft's flight manual etc* required Australian pilots to comply with that requirement.

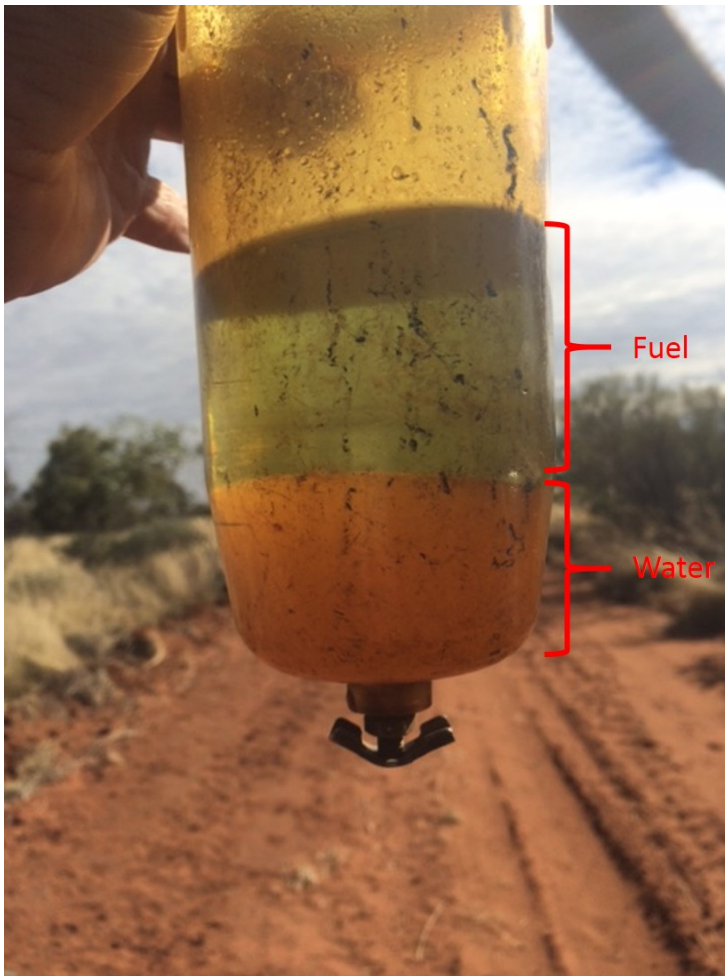
Figure 12: Unrelated example of a visual indication of water contamination in a fuel filter bowl

Although not captured in the ATSB's occurrence database, it was reported by a number of pilots using aviation drum fuel supply in Australia that they often identified water contamination in their fuel drums. The water contamination was normally identified using water detecting paste prior to refuelling, or by visually inspecting the hand pump filter bowl during the refuelling process (Figure 12). It was also reported that pilots would normally inspect fuel samples taken from the aircraft's fuel tanks after refuelling to confirm there was no contamination.
