ROBINSON HELICOPTER OCCURRENCE ANALYSIS

January 2017 - December 2022

Version 5.1

Date 30 May 2023

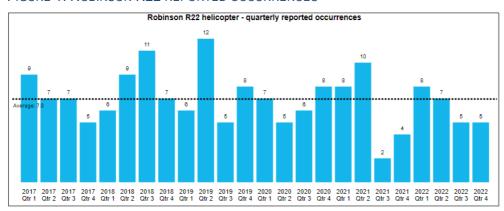
FIGURE 1: ROBINSON R22 REPORTED OCCURRENCES

A total of 167 occurrences for Robinson R22 helicopter were reported in the six-year period January 2017 - December 2022, averaging 7.0 per quarter, with no evidence of an increasing trend. Of the 167 reported occurrences, 70 were accidents, at an average of 2.9 per quarter.

There were 167 reported occurrences for Robinson R22 helicopters over the six-year period 2017 – 2022, an average of 7 per quarter. By comparison the Robinson R44 helicopter had 245 occurrences at an average of 10 per quarter. No evidence of an increasing trend was identified for either R22 or R44

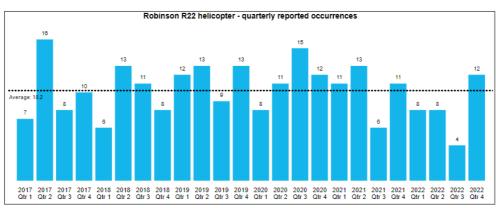
FIGURE 2: ROBINSON R44 REPORTED OCCURRENCES

A total of 245 occurrences for Robinson R44 helicopter were reported in the six-year period January 2017 - December 2022, averaging 10.2 per quarter, with no evidence of an increasing trend. Of the 245 occurrences, 44 accidents were reported, at an average of 1.8 per quarter.

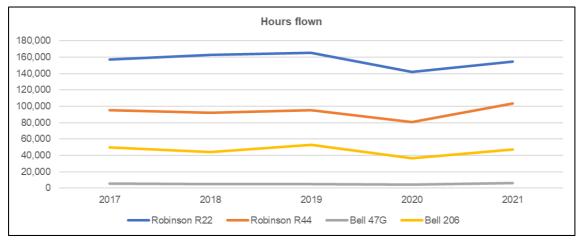
FIGURE 3: FLYING HOURS FOR RELEVANT HELICOPTER MODELS

Activity data for selected rotary aircraft models indicates that the Robinson R22 and R44 models have consistently flown the most hours in the period reviewed.

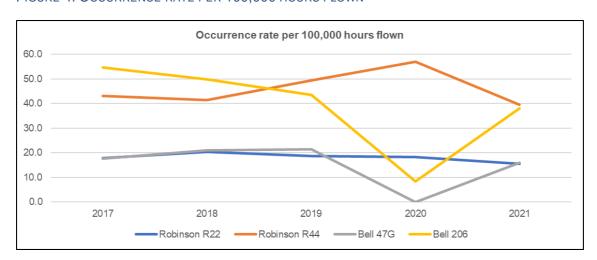
FIGURE 4: OCCURRENCE RATE PER 100,000 HOURS FLOWN

For the five-year period 2017 - 2021, the occurrence rate for R22 helicopters has averaged 0.18 per 100,000 hours flown. There was no observable trend identified over this period. This compares to the following helicopter models: R44 (0.46), Bell 47G (0.17); Bell 206 (0.37).

For the R22, the rate of reported occurrences (per 100,000 hours flown) averaged 18.2 over the five-year period 2017 to 2021. This rate is above the Bell 47G (11.5) and below each of R44 (45.7), Bell 206 (40.4) rotary aircraft. When comparing to fixed wing aircraft, the Cessna 172 (107.4) and Cessna 182 (95.4) recorded higher occurrence rates.

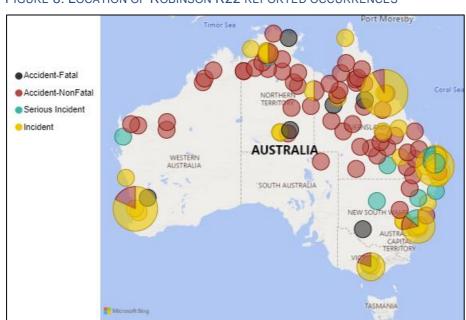
FIGURE 8: LOCATION OF ROBINSON R22 REPORTED OCCURRENCES

Forty-nine per cent of the R22 occurrences (Jan-2017 – Dec-2022) were recorded in Queensland (16% NT, 15% NSW, 14% WA). By comparison, 34% of occurrences for R44 were reported in Queensland (and 29% in NSW).

The analysis identified that 49% of the R22 occurrences (Jan-2017 – Dec-2022) occurred in Queensland. By comparison, 34% of occurrences for R44 occurred in Queensland (and 29% in NSW).
